PROGRAM TITAN IIIM

STANDARD SPACE LAUNCH VEHICLE
COMPONENT DEVELOPMENT REPORT

FOR THE
TITAN IIIM STAGE I COMBUSTION CHAMBER

9180-941-DR-3

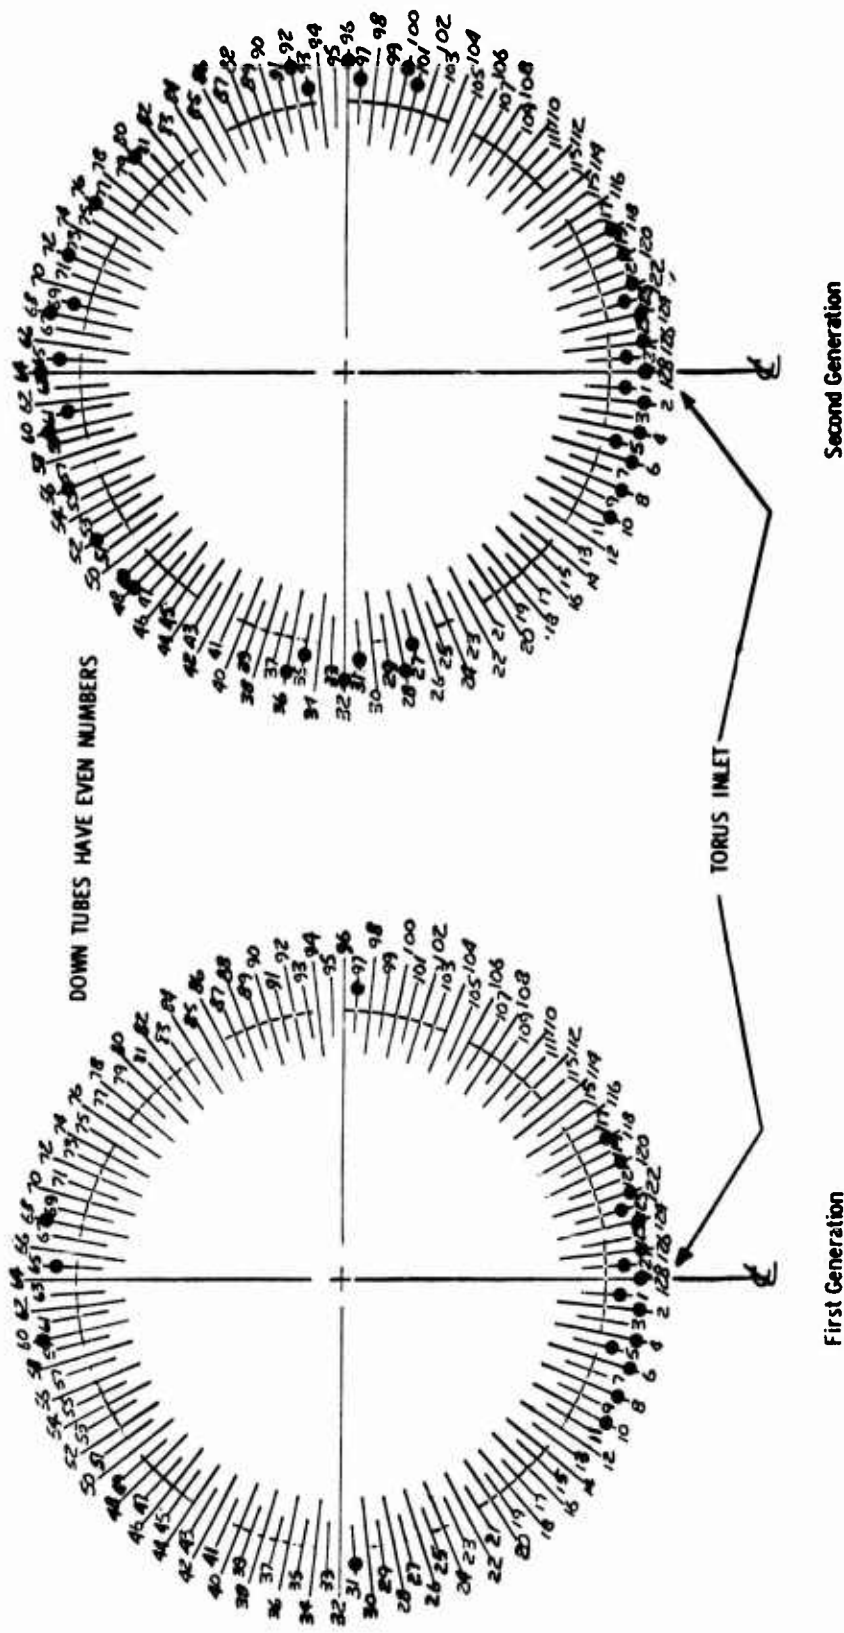
Figure 40. Pressure Tap Locations

(d) The pressure taps were located farther from the torus and the exit manifold ends of the tubes to reduce hydraulic entrance effects. Figure 40 illustrates the location of the tubes.

The most reliable data obtained during the various tests conducted disclosed a flow variation from -8.6% to +4.0% of the nominal weight flow per tube. The R_{BO} of the tube with least flow (-8.6%) was determined to be 0.765 with the engine operating at the worst chamber thermal conditions: $MR = 2.15$, $P_c = 796$ psia, $T_{ci} = 98^\circ F$, chamber film coolant - 10.5%. The actual R_{BO} is therefore within the design limit of 0.82.*

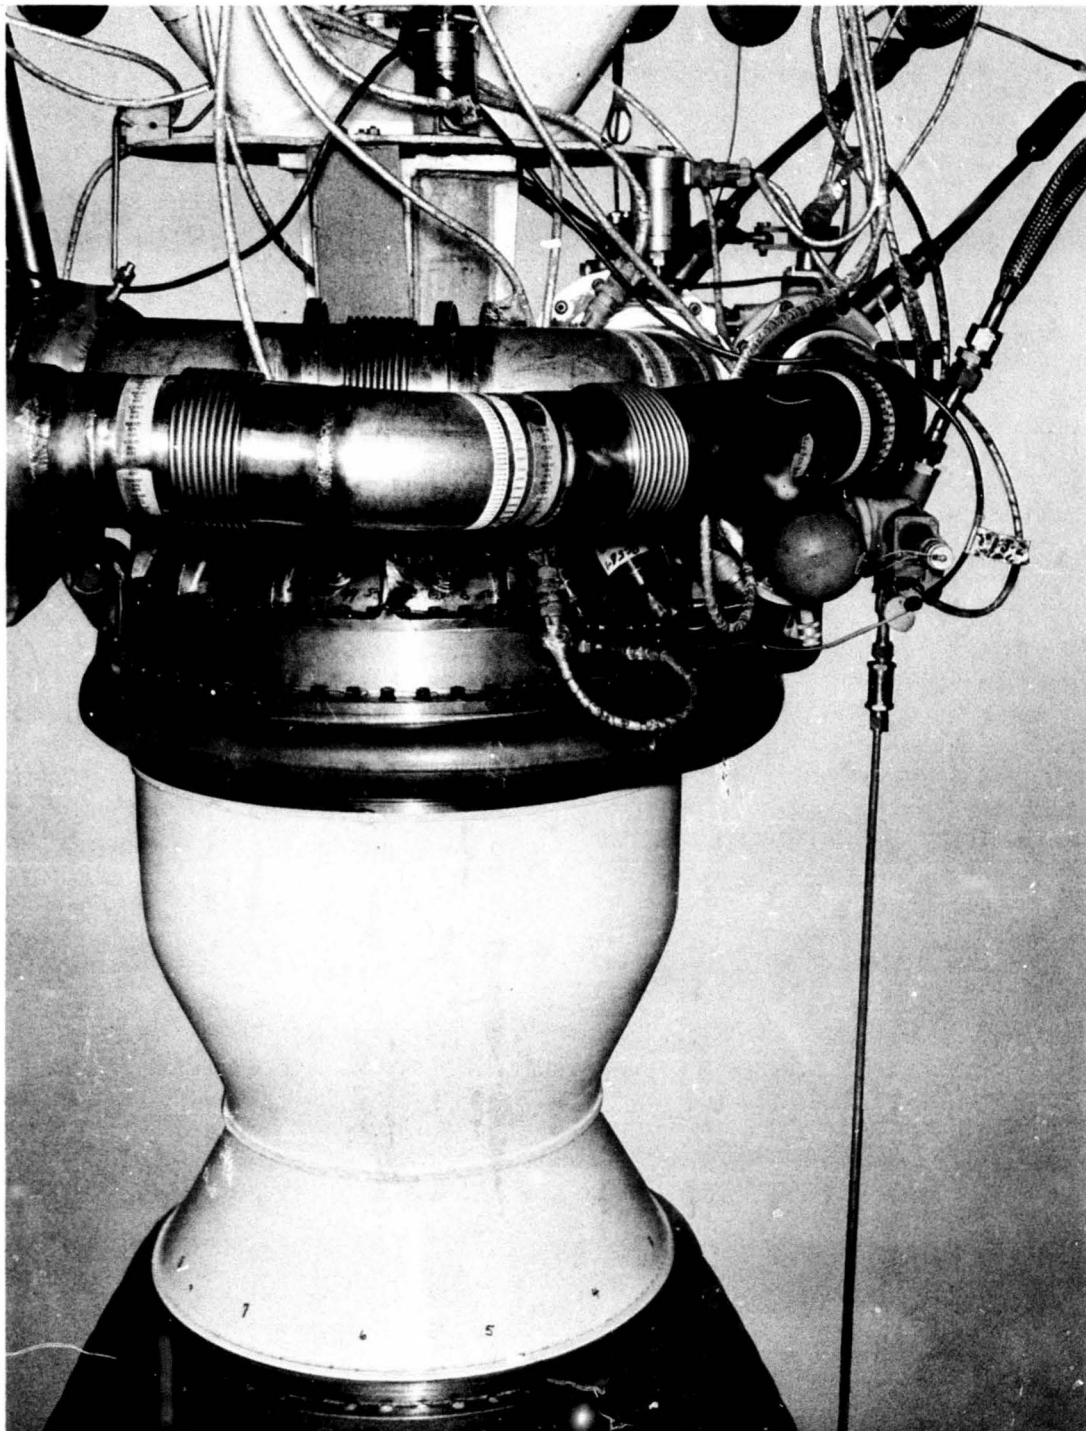
Figure 45 -- Chamber S/N 001 Prior to Test

Testing was initiated in May 1966, utilizing chamber S/N 001. The chamber was delivered to the test area without a shell in order to expedite testing because it was not scheduled to be tested in conjunction with a skirt. A prefire photograph of the TCA used in Test No. 001 is shown in Figure 45. The duration of the first test was approximately 31 sec with all parameters recording approximately the predicted values. Posttest hardware inspection indicated no heat marked tubes, no epon cracking, nor any other abnormalities.

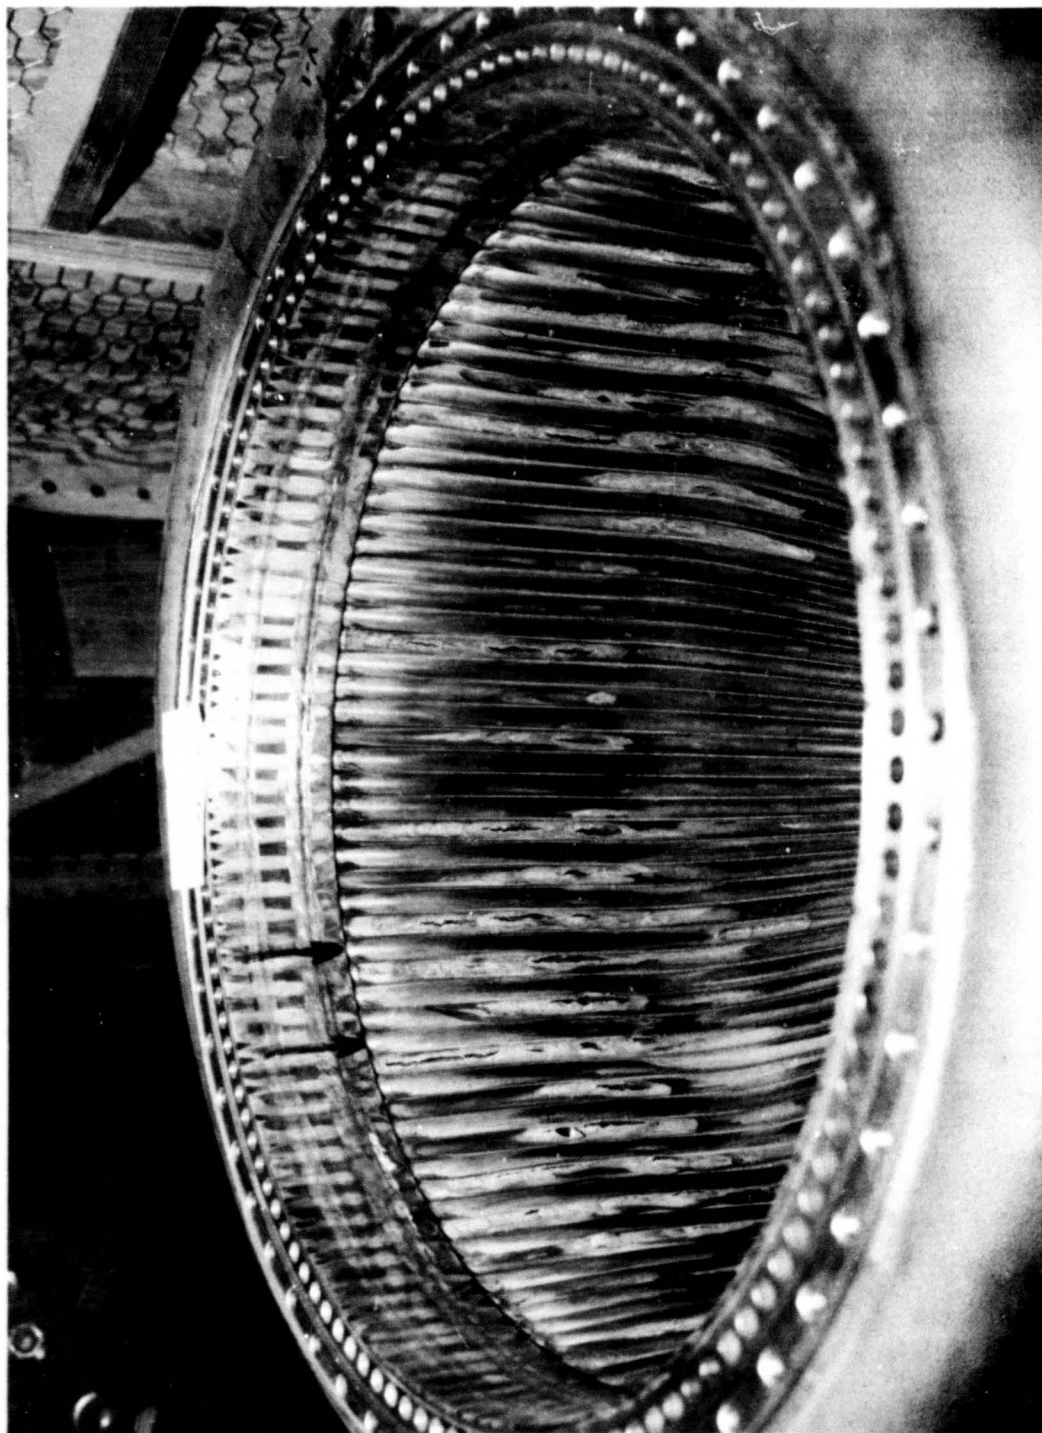
Figure 46 -- Chamber S/N 001 Posttest No. 3051-D01-1C-001

The test results showed that the 2BIE-38 injector was incompatible with the 87-11 chamber. The postfire inspection of the hardware revealed approximately 50 "up" tubes and 6 "down" tubes were failed (Figure 46) to the extent that chamber pressure and other parameters started dropping at $FS_1 + 4.5$ seconds.

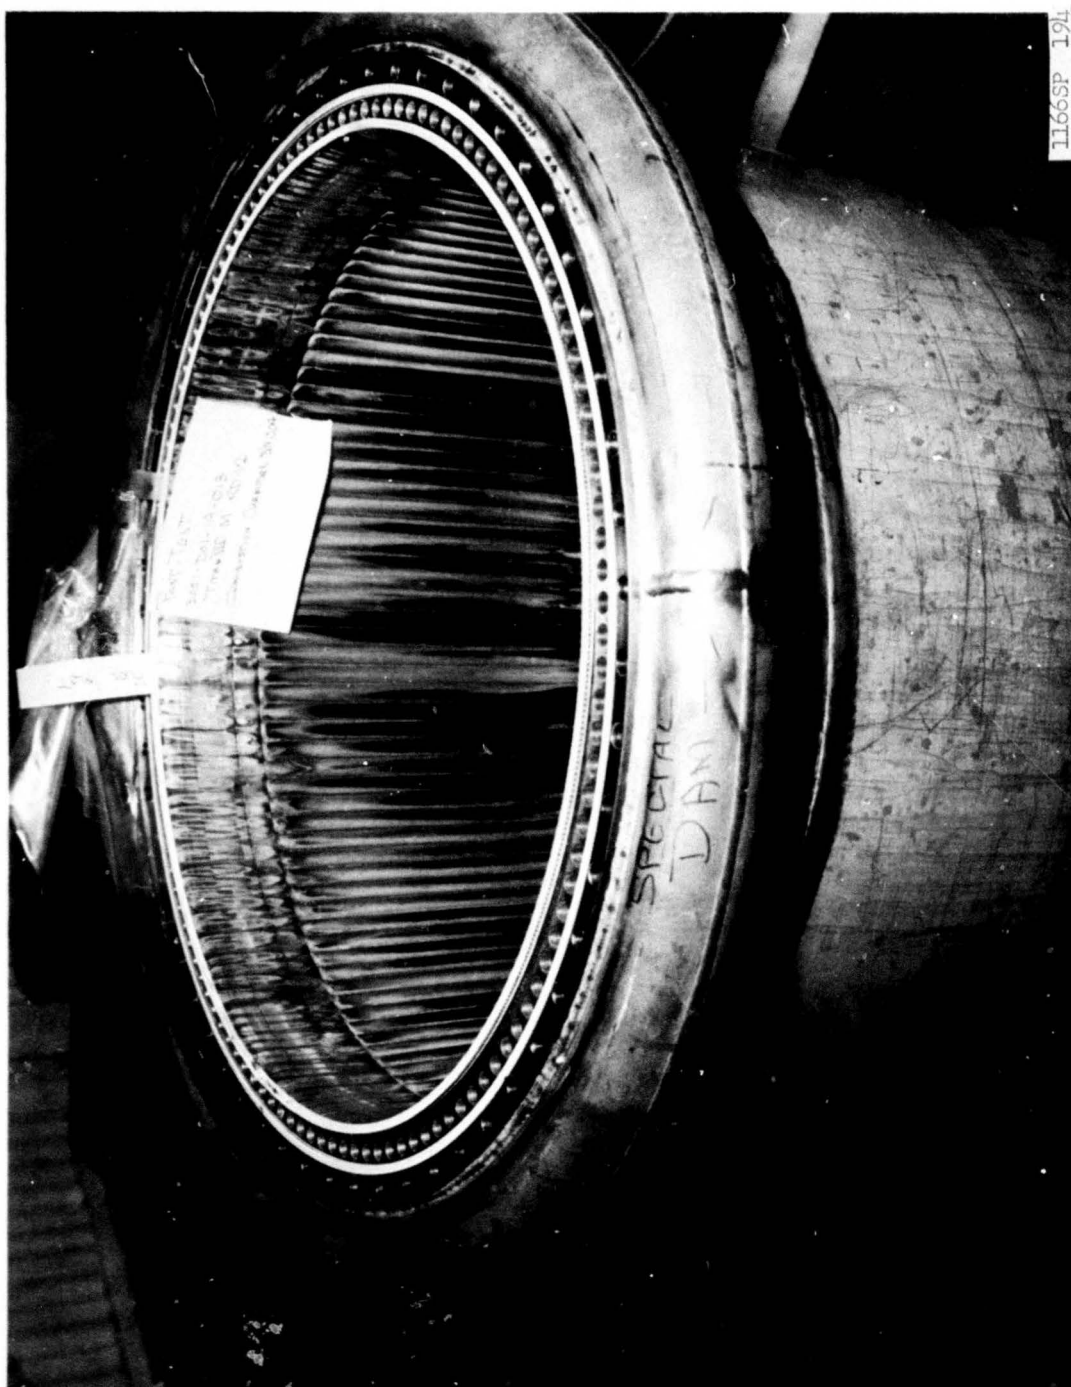
Figure 53 -- Acoustic Dam in Chamber Torus

Chamber S/N 004 had an acoustic dam in the torus (Figure 53) in an effort to reduce the magnitude of the feed system pressure amplitudes. The test was terminated after approximately 5 sec by the combustion stability monitor.

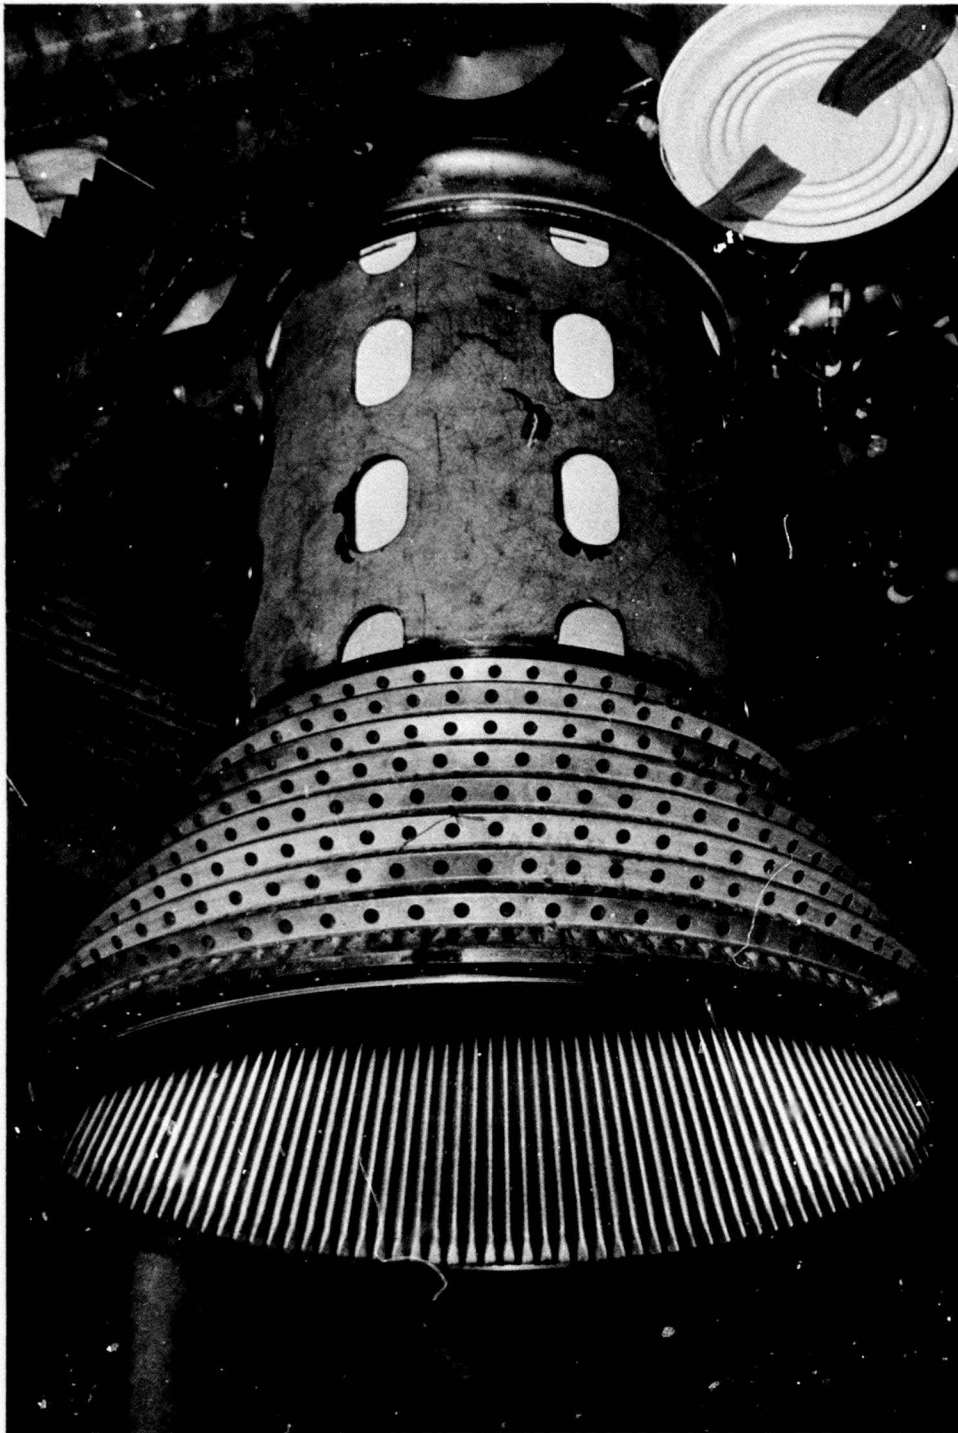
Figure 55 -- Chamber S/N 019 Prior to Start of Engine Demonstration

This unit had undergone considerable rework during fabrication; most notably, repair of the forward flange cover band which resulted in distortion to the flange that made remachining necessary. This chamber had therefore been withdrawn from the demonstration program but was substituted for chamber S/N 020 after Test No. -203.

Following Test No. -211, erosion was noted on the forward flange 2-in. above the joint with tube No. 64. The erosion was within the limits

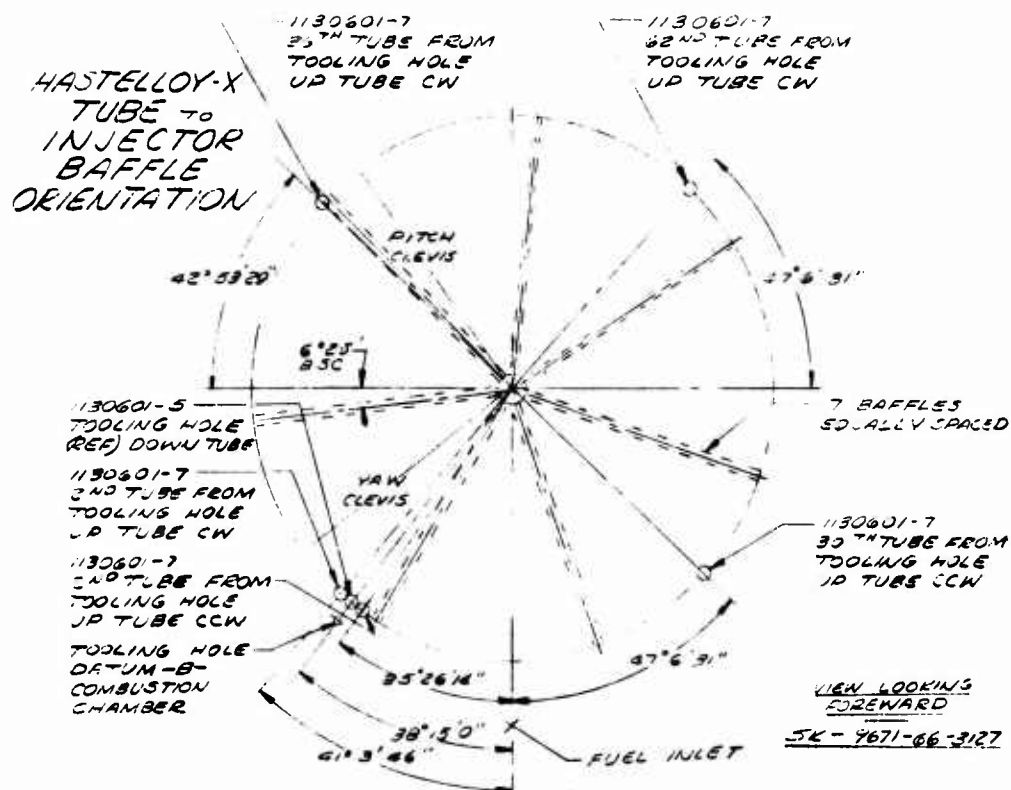
Figure 58 -- Location of Hastelloy Tubes in Chamber S/N 013

Figure 58 shows the location of Hastelloy-X tubes in the chamber relative to the injector mounting flange tooling hole.

This erosion occurred subsequently to the second braze cycle. Wax impressions were made of the eroded areas, bisected, and measured using an optical comparator. The depth of the erosion varied from tube to tube over a range of 0.005 in. to 0.020 in.

The eroded condition is attributed to the concentration of braze alloy which had been replaced in this area prior to the second braze cycle, coupled with the highest brazing temperature employed for the "A" revision braze alloy and the long duration of the braze cycle (30 minutes). The manganese-nickel binary equilibrium diagram shows a solid solution type diagram with a liquid phase occurring at 1840°F and 58 percent manganese. The reaction between the liquid manganese-base braze alloy with the nickel-base tube material at the brazing temperature resulted in the tube dissolution. The sixth tube did not erode because a tack weld joining the tube crown to the flange occupied this area.
